GAS ASSIST
CASE STUDY 322-1

FREEZER DOOR HANDLE

Freezer Door Handle

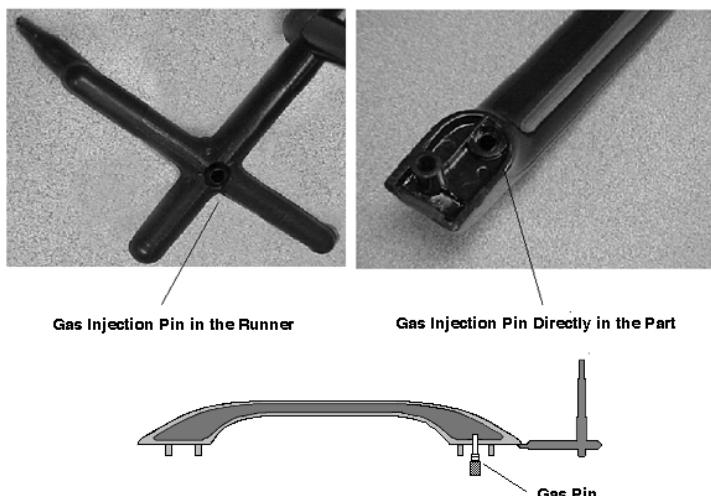
Fig. GP-1

FIGURE 322-1A When converted to gas assist, cycle time for this freezer door handle was reduced from 200 seconds to 105 seconds; shot weight was reduced from 261g to 192g; warpage, sink marks, and flow lines were eliminated; and scrap rate was reduced from 72 percent to 6 percent.

1. A very long cycle time of 200 seconds, due to the thickness of the part.
2. Dimensional stability was unattainable. Due to the thickness of the handle, warpage occurred. Even with the long cycle time, the tolerance between the four mounting bosses could not be held.
3. Sink marks were evident no matter how long the cycle time. This problem was magnified due to the mirror gloss finish on the part surface.
4. Flow lines and jetting on the part surface.
5. The parts had to be submerged into a tank of chilled water to try and help cooling.

Upon visual inspection of the parts, we found there were prominent flow lines on the part surface opposite the gate area. Hesitation lines were also evident where the short shot stopped before the gas took over the filling of the cavity. As the parts cooled, cavity # 1 showed a bad sink at the end of the fill. Each of these problems would need to be corrected for this project to be successful.

The first problem we addressed was the flow lines. As these flow lines were at the gate end of the parts, the problem was occurring before the gas was introduced. To correct the problem we started experimenting with different resin fill speeds. The problem was that the part was gated into a 1/4 inch ejector pin. This ejector pin then flowed into a 1 inch diameter section of the handle. As the resin came in contact with the mirror surface of the cavities, it cooled and rolled over creating the flow lines. We were able to correct this problem, by introducing the first 3/4 inch of shot at a very slow rate of speed (0.2 inches per second). This allowed the resin to puddle into the cavity without the rolling effect. After the first 3/4 inch of shot we increased the resin speed to 1.5 inches per second.

hesitation. We started by decreasing the gas delay timer in one second increments. When we reached zero on the delay time, the condition improved, but did not completely go away. Next we tried increasing the first stage gas pressure. This seemed to help a great deal. We ended up with zero gas delay, a first stage gas pressure of 4000 psi for 0.2 seconds, second stage gas pressure 2000 psi for 4.0 seconds, with the third stage at 1500 psi for 3.5 seconds. This provided the quick burst of speed, at the correct time, needed to eliminate the hesitation lines.

At this point, we had one acceptable part and one with a sink. To correct the sink, we needed to balance the tool. The mold was sent to the tool shop and flow restriction block inserts were placed into the runner system. Now the tedious job of balancing the cavities could be performed while the mold was running. We had a toolmaker grind the blocks while we weighed the cavities, and were able to get the parts within 1.5 grams of each other. This was sufficient to eliminate the sink at the end of the part.
